DPI Investigator

September 2012

TECH TERMS Liquid-Erosion Failure

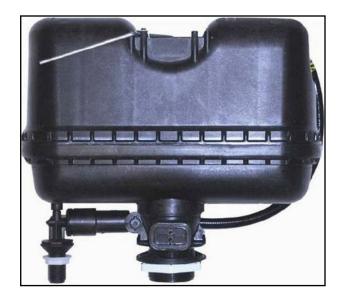
FOR IMMEDIATE RELEASE June 21, 2012 Release #12-201 Flushmate Recalls Flushmate® III Pressure-Assisted Flushing System Due to Impact and Laceration Hazards
