DPI Investigator

Spring 2013

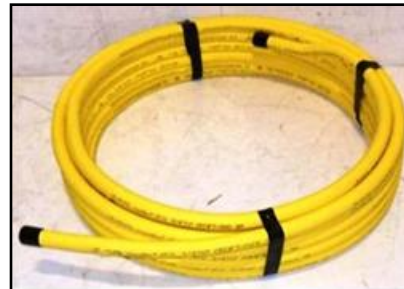
**Yellow CSST**

CSST Bonded For Protection

Failures of flexible yellow corrugated stainless steel tubing (CSST) used for natural gas and propane lines are becoming more common. A direct or indirect lightning strike may travel to the CSST and result in arcing and perforation of the tube. The electrical arcing may ignite the pressurized gas and result in a fire. Destructive inspection techniques are required to remove the yellow covering to confirm if arcing is present at any perforation or fracture of CSST. Please include on-site photos of the tube installation and the bonding wire/clamp points. More information can be found at www.csstsafety.com.
