DPI Investigator

Spring 2015

Trending Now at DPI

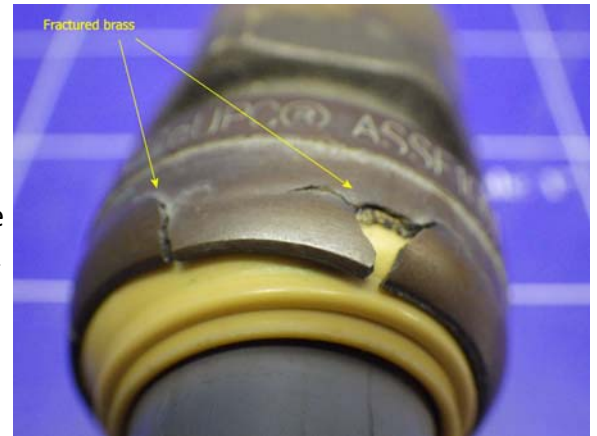
However, an unfortunate failure trend with these type fittings has been uncovered by DPI investigations. Some of the newer, lead-free fittings seem to have a

weaker structure at their openings. A thicker area of brass material thins out toward the opening as the part curves to house the interior components — especially the polymer retainer.

The weak area is likely caused by the absence of lead and the presence of materials more susceptible to water temperature and pressure variations encountered during normal operation. In any event, the brass material suffers minute fractures that penetrate to the area of thicker material and then spread along the circumference of the fitting.

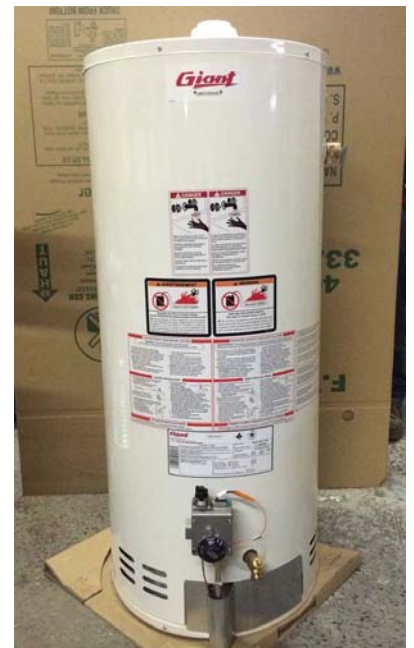
Hazard: On units with a space between the bottom of the water tank and the combustion chamber, the flame arrestor or flame arrestor plate can fail, posing a risk of fire or explosion if flammable liquids or gases are nearby.

Description: This recall involves atmospherically vented propane and natural gas water heaters in 30, 40, 50 and 60 gallon capacities. The recalled water heaters are white with a red “Giant” logo decal on the front. The water heaters have a nameplate near the gas valve with the model number, date of manufacture and serial number. Check the link below for model number and serial number ranges:
