DPI Investigator

Fall 2016

Trending Now - Recall Alert

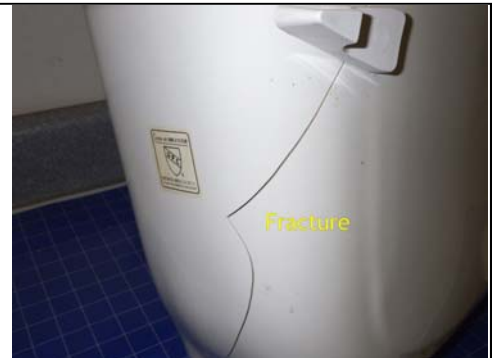
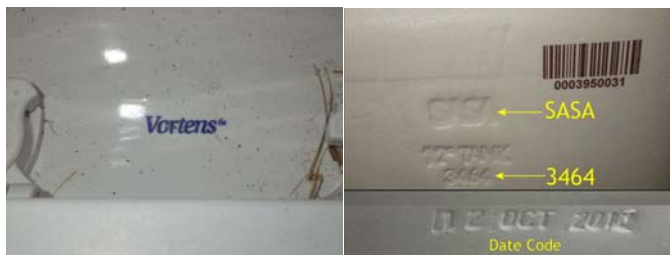
Over the past year, DPI has received multiple **Vortens toilet assemblies** for inspection. The discovered common failure mode is fracturing of the toilet tank (example in top left photo). The fracturing can be found in any area of the tank, but it usually occurs in a vertical manner from top to bottom.

The inspected tanks have failed by fracture, and none have suffered external impact damage that would cause such extensive fracturing, nor have they been subjected to freezing temperatures.

Product markings (photos left) of Vortens™ appear printed on the top rear of the bowl. Additional markings can be found stamped into the tank interior and can include SASA (manufacturer's mark), 3464 and a day/month/year date code.
