DPI Investigator

August 2012

STOP! Put the wrench down...

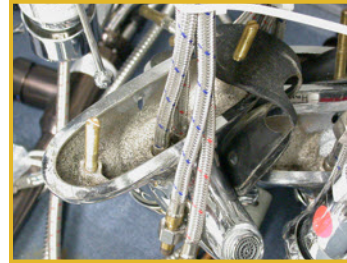
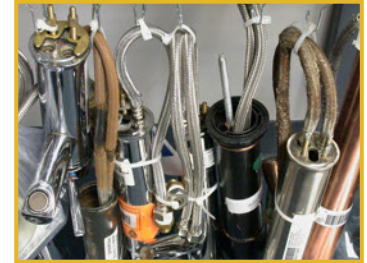
Factory Installed Faucet Supply Lines

Ruptured stainless steel braided supply lines arrive almost daily at DPI. One really ill-conceived design has to do with using the smallest sizes of these lines to supply single-handle kitchen and bath faucets. The lines are factory installed, very prone to rupture, difficult to service, and often unmarked.

Please *do not remove* these lines from the faucet or the fixtures that they originally came with. Many are unmarked and may be unidentifiable if the other components are not included. Send on-site photos, claim history, and all of the components that can be retrieved to obtain the best inspection.

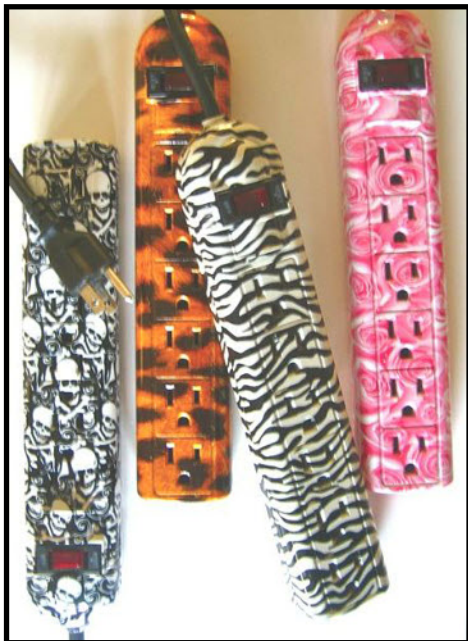
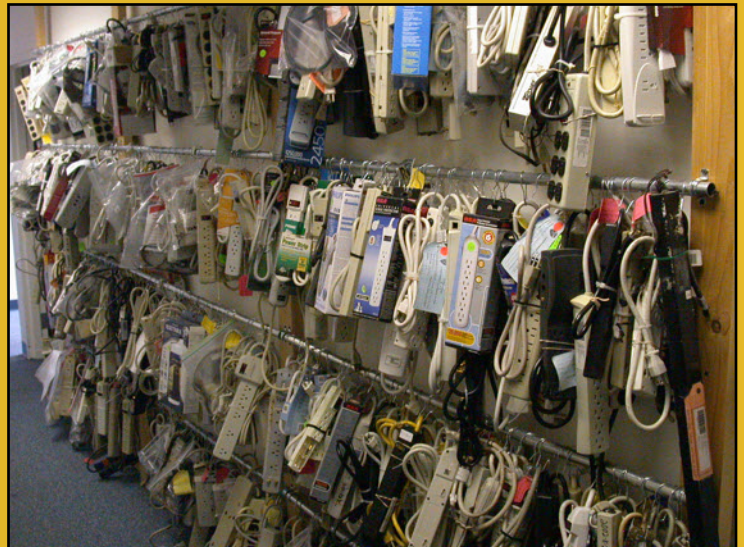
Burlington Coat Factory Recalls Power Strips Due to Fire Hazard

Power strips are often difficult to identify, especially after being fire damaged. Many failure analysis labs and engineers count on the DPI Research Department with its large collection of exemplars to provide the answers they need.

WASHINGTON, D.C. - The U.S. Consumer Product Safety Commission, in cooperation with the firm named below, today announced a voluntary recall of the following consumer product. Consumers should stop using recalled products immediately unless otherwise instructed. It is illegal to resell or attempt to resell a recalled consumer product. **Name of Product:** Lush Life® power strips **Units:** About 6,000 **Importer:** Lush Life, of LaJolla, Calif. **Distributor:** Burlington Coat Factory, of Burlington, N.J. **Hazard:** The power strips have undersized wiring which poses a risk of shock to consumers. In addition, the wiring and plastic strip fail to meet fire resistance safety standards, posing a fire hazard to consumers. **Incidents/Injuries:** None reported. **Description:** This recall involves four designs of power strips. The vibrantly designed power strips come in four prints including, leopard, rose, skull and zebra. Model numbers 12256, 12257, 22563 and 22575 can be found on the six-outlet power strip. **Sold at:** Burlington Coat Factory, The Container Store and other retail stores nationwide from July 2011 through March 2012 for about \$10. **Manufactured in:** China **Remedy:** Consumers should immediately stop using the power strips and return them to the place of purchase for a full refund or store credit. **Consumer Contact:** For additional information, please contact the firm toll-free at (888) 223-2628 between 8:30 a.m. through 6 p.m. ET Monday through Friday, or visit the firm's website at www.burlingtoncoatfactory.com
