DPI Investigator

March 2019

Trending Now at DPI

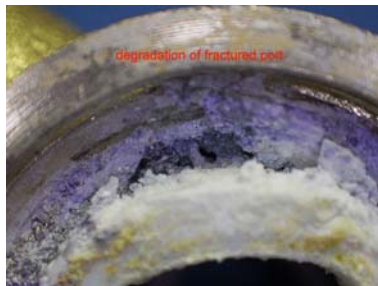
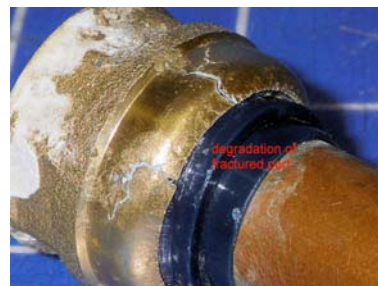
Since the introduction of “no lead” laws across the country, DPI has seen an increase in the amount of failed single-handle valves. Either due to changes in design, the use of lower quality materials, or both of these factors, some valves seem to have less reliability than before. Recently, DPI has received more of these valves where sections have completely fractured and separated, and the brass material has deteriorated (left photo) after a short time in service. Also, some of these valves suffer multiple small cracks at one port or another (right photo). Click [here](#) for more detailed information.

Household single-handle valves are usually installed in-line with plumbing and are thus situated behind walls, under floors and so on. And even though they are designed to control water flow, such valves are typically installed and remain in an open position. Traditionally, these valves were made of sturdy materials and offered long-term performance.
